THE FIX FOR SPRINTER™ TURBO HOSES CRACKING ON 2007 TO 2010, 3.0 LITER V6 ENGINES

DIRECTIONS FOR INSTALLING THE SPRINTER™ TURBO HOSE ADAPTER

Part Number: ADAP09™

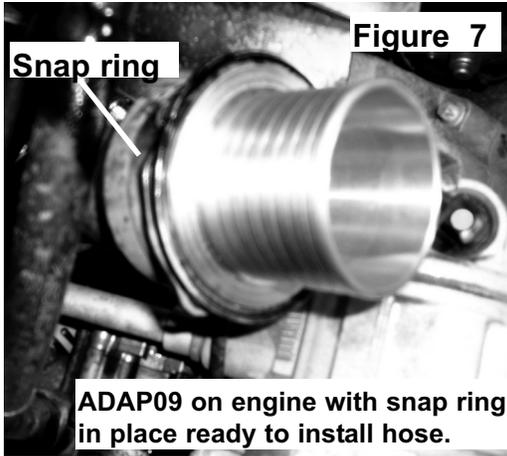
Figure 7

replace the snap ring in the same position as it was originally. This will hold the ADAP09 in place. See (Figure 7).

8.) Place the new clamp supplied in your kit over the end of the hose, but do NOT tighten it yet. Slide the end of the hose over the **already installed ADAP09**, See (Figure 7), using the method shown in (Figure 9) and push the hose on all the way to the "stop-flange" on the ADAP09 as seen in (Figure 10).

10.) Do a final check of the alignment of the hose itself and then tighten the clamp on the engine intake side onto the already installed ADAP09 as seen in (Figure 7). Move the clamp at the [A@Á æ Á] [æ æ • Á@Á] [Á] Area of the ADAP09 as shown in (Figure 10) hold it in place and tighten the clamp **FIRMLY**.

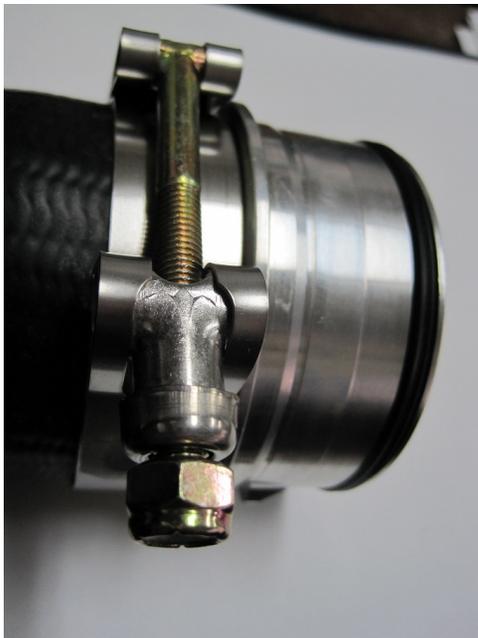
Figure 10

(Clamp is shown Un-tightened in Figure 10. BE SURE to tighten to a minimum of 60 inch pounds)

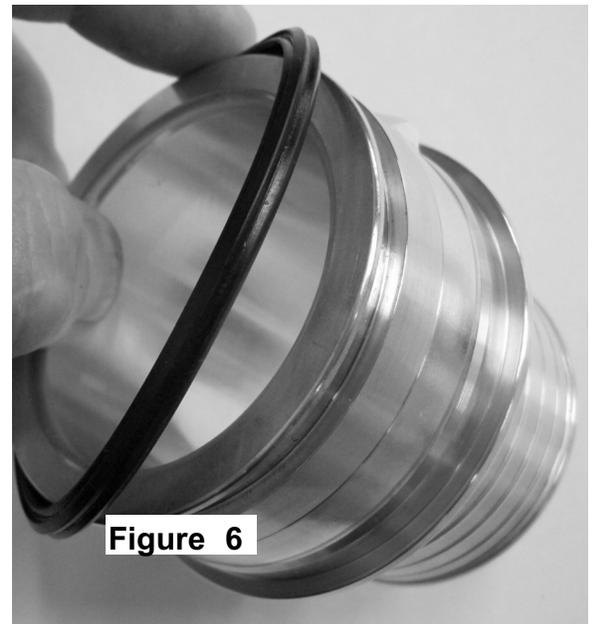
Figure 6

5.) Remove the "O-ring" gently from the end of the metal fitting with your fingers, See **(Figure 5)** and place the O-ring on the ADAP09 in the same manner as it was on the original metal fitting. See **(Figure 6)** on page 2.

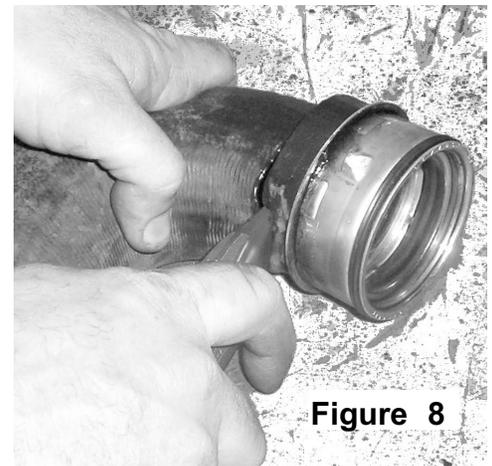
Figure 8

7.) Next, take a single-edged razor blade or box cutter with a sharp blade and cut the original fitting off the hose, using the original metal fitting as a "cutting template" see (Figure 8). Once the hose has been cut **cleanly** away from the original fitting, discard the fitting and clean the inside of the hose with a clean dry shop rag to remove oily deposits. Blow out any particulates out with air.
